# Manhole Inspection Summary

Manhole # S43UU\_040MH

Insp Date: **2/12/07 12:01 PM**

**Location** Address: **1601 ABBOTSTON ST**

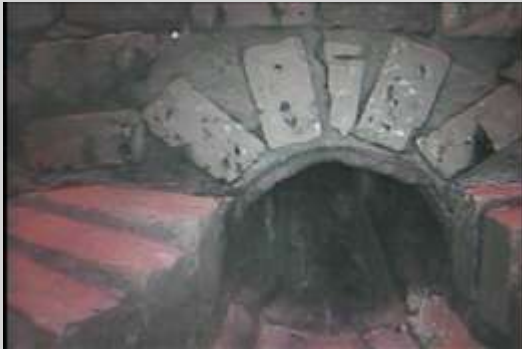
### 8 in. Circular Gravity Sewer Pipe Out @ 12 O'Clock

Pipe Material: **Clay** ☐ Pipe Lined

Invert Depth: **12.13** (ft.) Flow Characteristics: **Slow**

Infiltration: **None** Pipe Seal Cond: **Unknown**

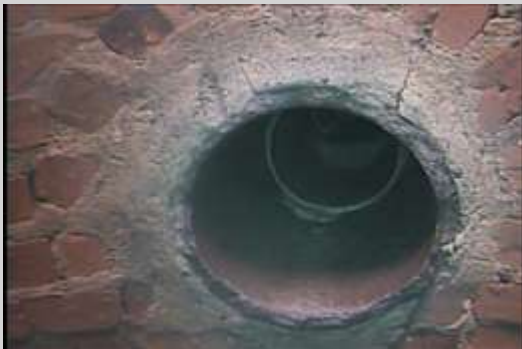
### 8 in. Circular Gravity Sewer Pipe In @ 3 O'Clock

Pipe Material: **Clay** ☐ Pipe Lined

Invert Depth: **7.31** (ft.) Flow Characteristics: **Slow**

Infiltration: **None** Pipe Seal Cond: **Unknown**

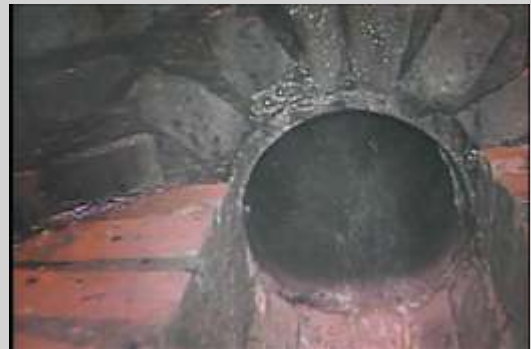
### Drop In @ 3 O'Clock

Drop: **Outside** Rod and Bar

Drop Condition: **Open**
